Hanchett-Bartlett House  
2149 St Lawrence Ave  
Beloit, WI 53511

# Condition Report for 2149 St Lawrence Ave Beloit, Wisconsin

Angus-Young Associates, 608-756-2326  
555 S. River Street - Janesville, WI 53548  
5/17/2019

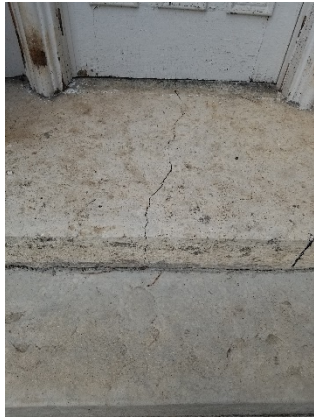
The house includes stone steps at the main entrance. The steps have cracks, open joints between stone pieces. (See Photos A-7-8) Cracks should be filled with caulk and joints should be tuck pointed and grouted. The concrete exterior stair to the side entrance to the house is appears to be in tact with only minor rusting where the guard rails meet the concrete decking.

A-7: Crack at Entrance Stone

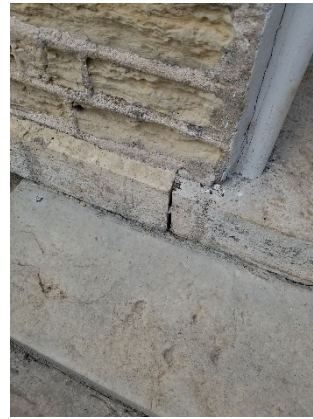
A-8: Entry Open Stone Joints

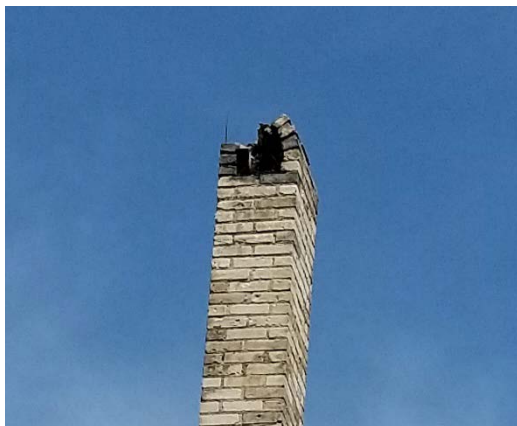
The house exterior stone walls are in need of tuck pointing. One specific area of concern is the south west corner of the house has significant loss of mortar in the stone joint on the west wall. All other areas of the house require attention. Tuckpointing process should also remove any inappropriate mortar material, (Photo A-10) concrete used as mortar and caulk that may have been used in place of mortar in some areas. Some joints were filled with modern gray mortar that is cracking and delaminating. Care should be given to the type of mortar used for the tuckpointing. Samples of the mortar should be taken and analyzed for chemical make-up and similar mortar should be used. This is important to equalize the water absorption and brittleness of new mortar with the original mortar. Other masonry repairs include replacing the top of chimney with ne brick (Photo A-11).

A-11: Chimney Top

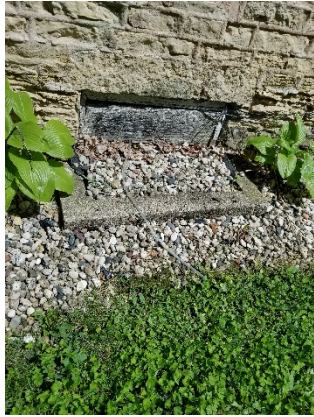
Many of the basement windows have been infilled with wood framing and window wells with stone fill material. (Photo A-13). These areas appear to be sources of water in the basement. Removal of the wood infill materials and blocking of windows with masonry materials or new windows should be considered. Regrading in the immediate area of the window wells to reduce the amount of water in these areas will reduce the risk of water in the basement.

A-13: Infilled Basement Window

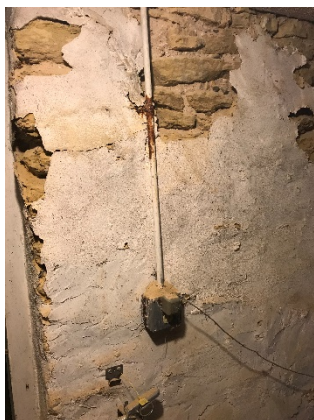
House interior basement foundation wall was parged with a plaster coating. (Photo A-17) In some areas this is spalling due to moisture in the stone foundation. These areas should be tuckpointed where possible and new parging installed. If painting of this surface is desired, these areas should be painted with painting material that allows the transfer of moisture vapor to reduce delamination of the paint coating.

A-17: Basement Wall Peeling

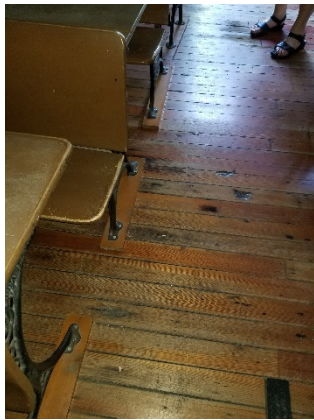
The School House was moved to the site in recent years. The school exterior siding and roof are in adequate condition. The floor of the school is showing signs of moisture deterioration. (Photo A-22) This is due to the crawl space below this framing is not vented in any way. (Photo A-23) This is trapping moisture and advancing deterioration in

A-22: School House Floor

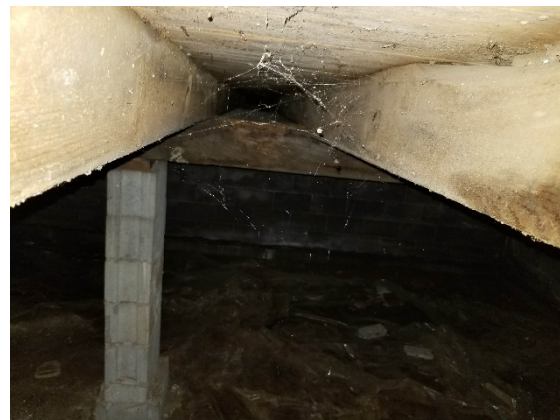
the floor joists and decking of the school. This space was accessible by a small hole in the siding, it is expected that no vapor barrier is installed on the soil. The crawl space should be vented with a open louver or wire screen placed on opposite sides of the building at a size of 3 square feet of free air area total of two openings. The size of these fixed framed louvers should be a louver 24" x 18" in size. School House has a dehumidifier placed in the building. The drain hose of this unit is kinked and most likely not allowing water to flow. This should be replaced with a rigid pvc pipe to ensure flow of drain water. (Photo A-28)

A-23: School House Crawlspace

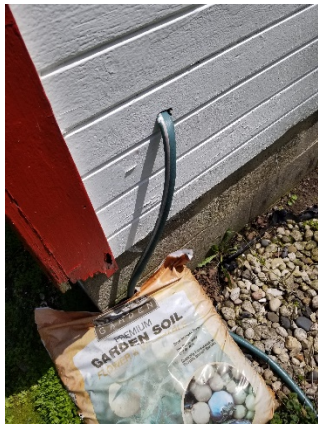
A-28: School House Dehumidifier Hose

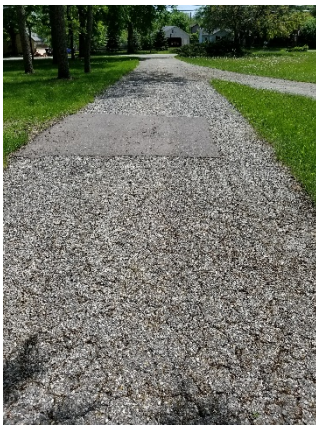
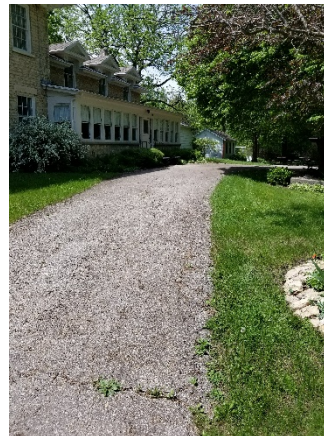
The property has a paved drive with turn around and minimal dedicated paved parking onsite for about four cars. Paving is broken, cracked and deformed. (See Photos A-30 and 31) A brick paver path leads to the main entrance to the house. This path is uneven and displaced in some areas and could pose a trip hazard to an infirm person. The majority of the site is mowed grass lawn, including approaches to the School House, Barn and Shed.

A-30: Paving Condition

A-31: Paving Condition

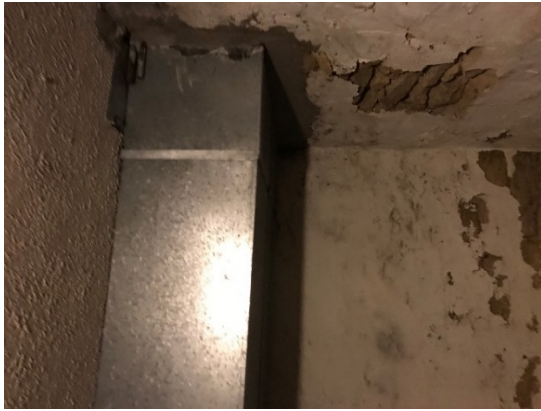
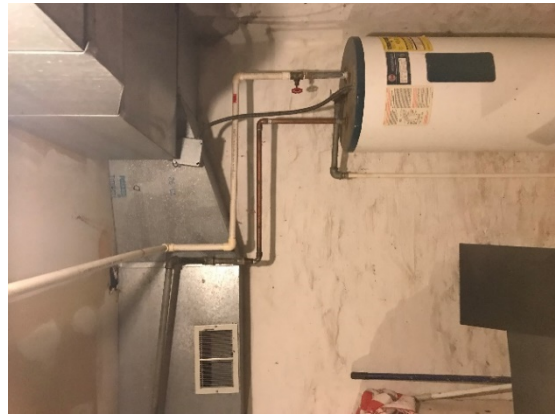
Portions of the air distribution ductwork associated with the furnaces located in the basement appears to be 20+ years old. Based on the age of the building, and the existing conditions, the existing ductwork is in need of cleaning and may be approaching the useful life expectancy published by ASHRAE. The American Society of Heating, Refrigeration and Air Conditioning Engineers have published a useful service life of 30 years for ductwork. Refer to M-1 and M-2 for information related to existing conditions.

M-1: Existing Ductwork

M-2: Existing Ductwork

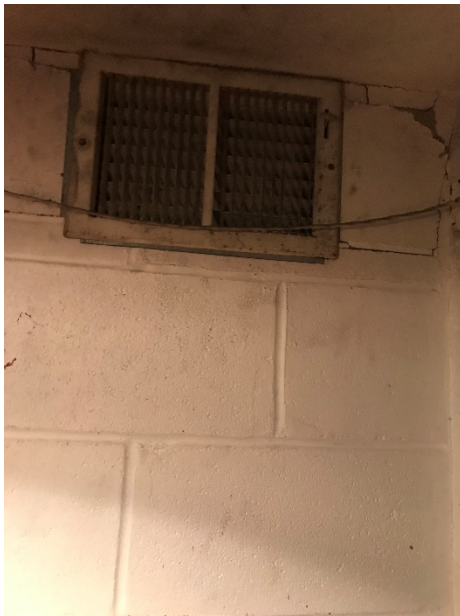
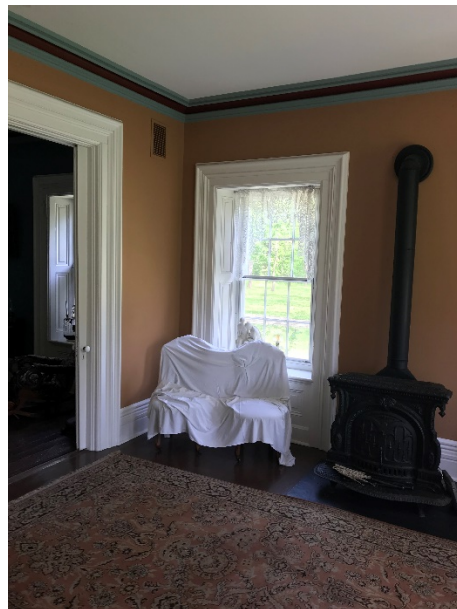
The space is primarily served with surface mounted grilles, registers and diffusers. A majority of the grilles, registers, and diffusers appeared to be the same age as the ductwork and are in need of cleaning, or replacement. (Refer to image M-3 and M-4)

M-3: Existing Grille

M-4: Existing Grille

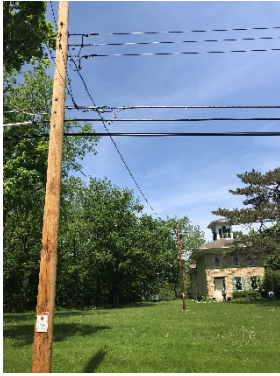
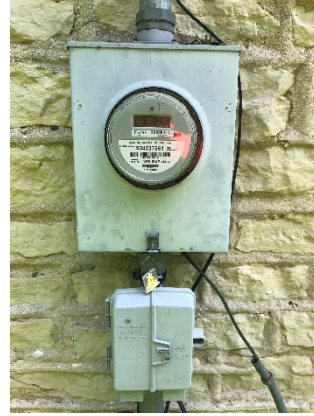
Alliant Energy is the service Utility provider and enters the property via overhead line with one pole to support the overhead line halfway through the front yard. The electric meter is located on the west side of the main house, and appears to be in good operational condition and the meter recently updated in the past ten years. (Photo E-1 and E-2).

E-1: Overhead Electrical Service

E-2: Service Meter/ Telephone NID

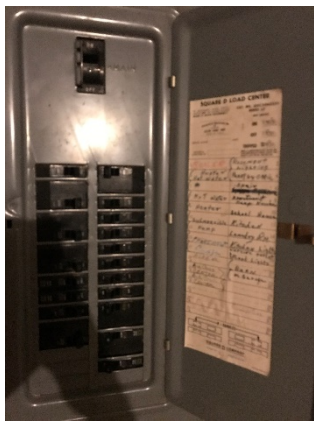
The main distribution panel (Photo E-3) is a 200 amp, 240/120 volt single phase panelboard with a 200 amp main breaker disconnect. The panelboard appears to be in fair condition but is estimated to be over twenty years old and the circuit breakers may be nearing the end of their useful life. It is recommended that a licensed electrician perform periodic maintenance on this panel board and assess the circuit breaker and internal wiring conditions for potential future replacement.

E-3: Main Disconnect/Breaker Panel

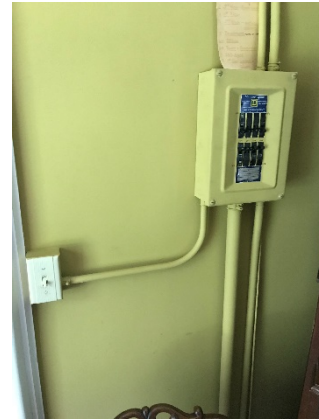
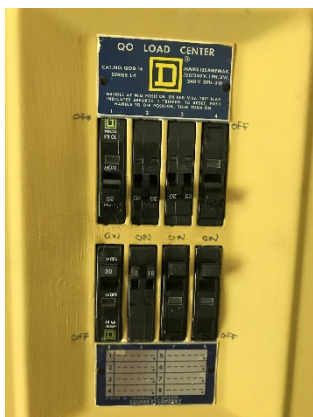
There are 3 panelboards located throughout the property that are fed from the main breaker panel. The first floor panelboard (Photo E-4 and E-5) is a 125 amp rated, 240/120 volt single phase panelboard. There is no room for future expansion on this panel and it appears to be in fair condition but is estimated to be over twenty years old and is recommended that a licensed electrician perform periodic maintenance and assess the internal conditions for potential future replacement. The schoolhouse panelboard (Photo E-6) is a 100 amp rated, 240/120 volt single phase six space panelboard. There are two spaces open and the panelboard would accept up to six tandem breakers to extend the circuit but due to the age and condition of the panelboard it is recommended that the panelboard and its associated feeder and branches have their condition assessed by a licensed electrician and replaced in the near future if necessary. The garage panelboard is a 100 amp rated, 240/120 volt single phase six space panelboard with three spaces open and the ability to accept tandem breakers for more circuit capacity. The panel is in poor condition and is recommended for immediate replacement at which time the feeder condition should be assessed by a licensed electrician as well.

E-4: First Floor Panel

E-5: First Floor Panel Breakers

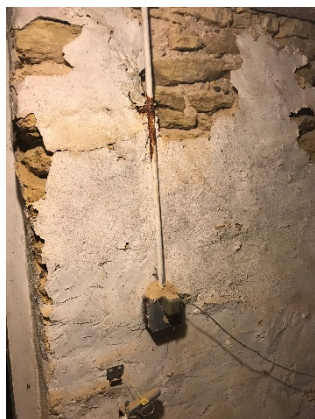
EMT raceway that was in the basement seemed to be in good condition except for a few moisture damaged pieces that need to be replaced (Photo E-9) the condition of the wires should be assessed at that time as well. EMT conduit that was visible on the first floor seemed to be in good condition, but the wiring within the walls is unknown. Knob and Tube wiring and cloth wiring are both present throughout the site and should be investigated and confirmed to be disconnected on both ends (Photo E-10 thru E-12). It was noted at the schoolhouse that some of the receptacles and lighting was not functioning and it is recommended that the wiring and conduit conditions be evaluated for moisture and age related damage immediately to ensure they are up to code. Likewise, the panelboard in the garage shows signs of rust and moisture damage so the conduit and wiring in this area should be evaluated for replacement soon as well.

E-9: Basement - Rusty Conduit

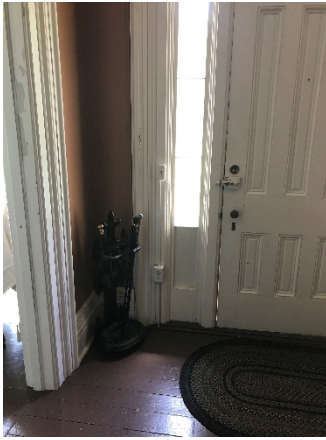
The house interior outlets and switches appear to be in good condition but due to the age of some of the devices it is recommended that they be inspected for proper grounding and replaced if necessary (Photos E-13). It was noted that the bathroom receptacle (Photo E-14) needs to be replaced with a GFCI receptacle immediately to meet NEC requirements. The exterior GFCI receptacle should have its weatherproof cover replaced. As mentioned previously the receptacles in the schoolhouse (Photo E-15) are said to not be functional, due to their age and location conditions it is highly likely they will need to be replaced. The receptacles located in the garage appear to be in fair condition but due to the conditions of the panelboard and conduit should be inspected to ensure they are still in good condition and grounded properly.

E-13: First Floor Receptacles and Switches

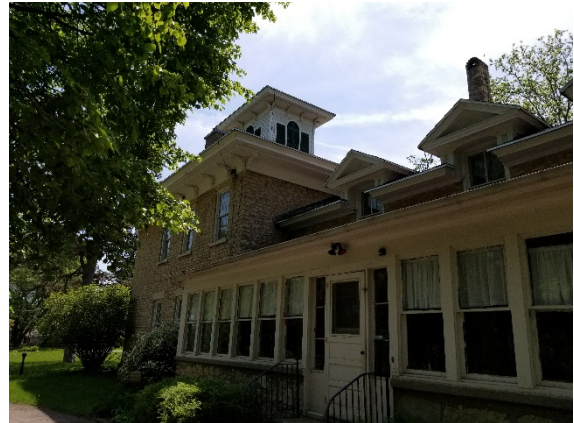
fixture above the east porch entry and one dual head fixture on the northern east side of the house and one on the north side of the house (Photo E-16). The lamps in these fixtures should be replaced with LED equivalent bulbs as they fail and the wall pack fixture is very aged and should be replaced with an LED wall pack. The schoolhouse exterior has a dual-head fixture on the south end of the building and an empty light fixture above the west entrance. The dual-head fixture should be re-lamped with equivalent LED bulbs when the current ones fail and if lighting is desired at the west schoolhouse entrance the fixture is old enough that it should be replaced entirely with an LED fixture. The garage exterior has a dual-head fixture above the entrance with one broken lamp (Photo E-17). It is recommended that these lamps be replaced immediately with LED equivalent lamps.

E-16: East Exterior House Lighting

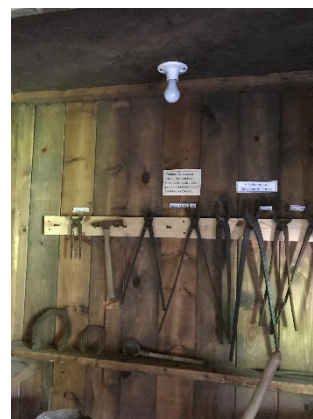
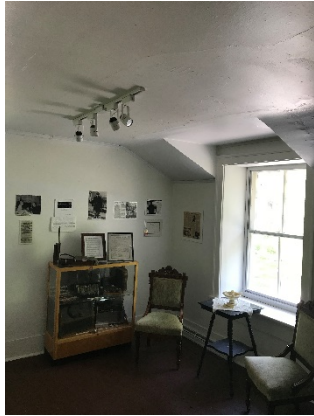
Interior lighting fixtures throughout the main house are a mixture of Edison base, fixtures with CFL bulbs and track lighting for displays on the second floor (Photos E-18 and E-19). The porch contains two decorative Edison base fixtures. Fixtures throughout appeared to be in reasonable working condition with the exception of a pair of flying leads in the wood stove area, these wires could be inspected in the future for condition and used to provide power to a new fixture here. It is recommended that the lamps on all fixtures be switched over to LED bulbs as they fail to save costs on energy consumption. The schoolhouse was found to have no interior lighting present, besides decorative oil lamps. The garage was found to contain Edison base incandescent lamps and halogen lamps. It is recommended that these lamps be replaced with their LED equivalents as they fail to save energy costs.

E-18: Typical Edison Base Incandescent

E-19: Second Floor Display Lighting

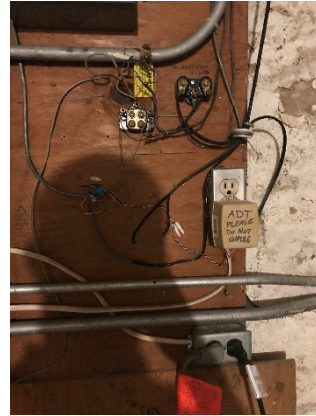
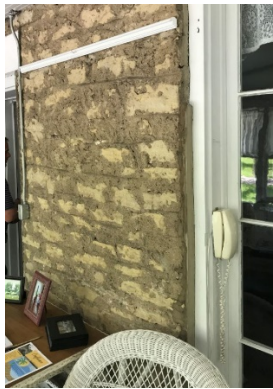
Investigation of the cabling was found to be in old condition (Photo E-20). The only observed station jacks was on the front porch (Photo E-21).

E-20: Telephone Location

E-21: Telephone Location

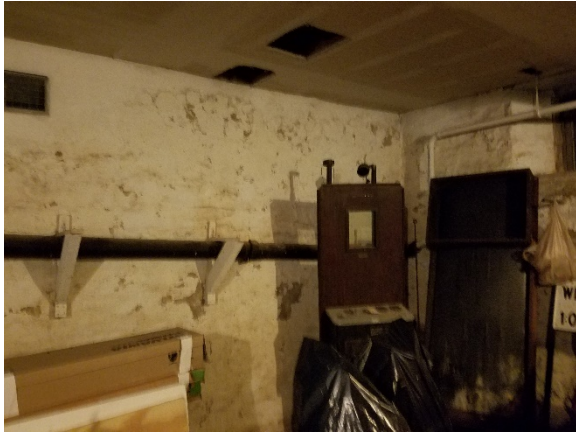
There is an existing septic system which has failed and is required to be abandoned in accordance with Wisconsin Administrative Code SPS 382.33. A new 4" sanitary sewer lateral needs to be installed from the entry (Photo P-1) and exit point (Photo P-4) of the building to an existing sewer lateral tap located 110' west of the nearest manhole located in St. Lawrence Ave. Lime rock is expected to be encountered during the excavation which will significantly increase the cost of the installation.

P-1: 4" Sanitary lateral entry

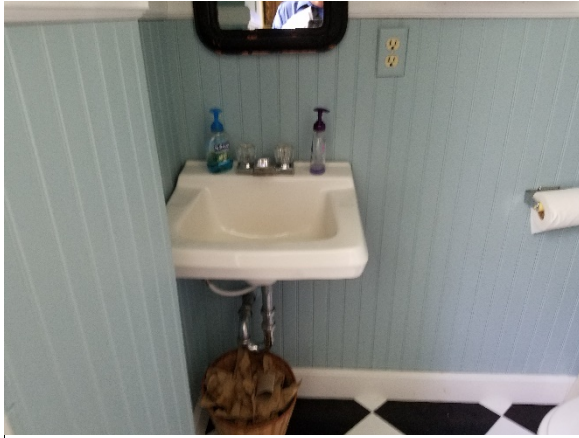
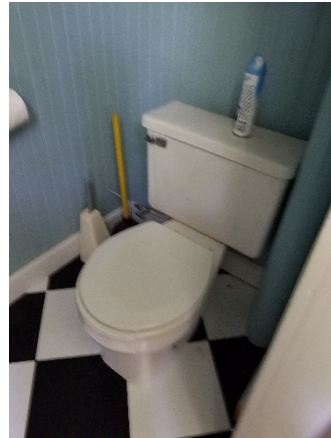
The existing bathroom fixtures do not meet current ADA guidelines nor does the water closet meet water conservation regulations. (Photo P-7 & P-8) The fixtures are required to be replaced. Wisconsin Plumbing code requires a bath or shower for a residence so a bath or shower will need to be added. The kitchen sink and faucet appear to be serviceable however the drain is required to be rebuilt because there is back pitch in the continuous waste pipe. Exterior hose bibs are required to be replaced with approved frost proof hose bibbs.

P-7: Existing lavatory

P-8: Existing Water Closet

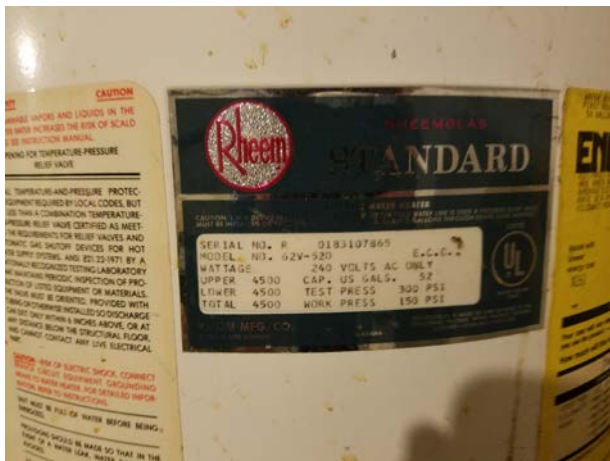
The 52 gallon electric water was manufactured in January 1983 and exceeds expected useful life expectancy and needs to be replaced. (Photo P-9)

P-9: Water Heater Label - 1<sup>st</sup> four numbers of serial number indicates date of manufacture.
